Economical, Innovative Methods of Straightening ESP Collector Plates So As to Achieve Alignment for the Purposes of Improving Particulate Control and Performance

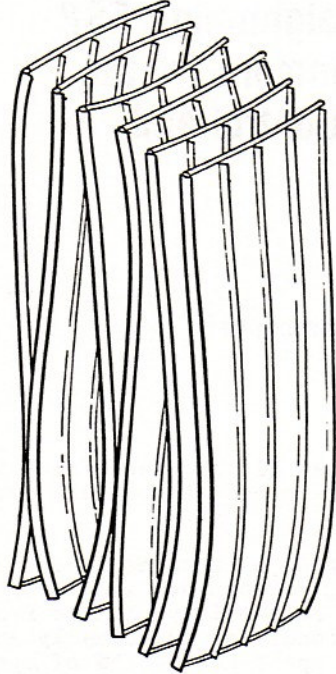
FIG. 1 COLLECTOR PLATE DISTORTION

tortion can be severe, with the typical minimum electrode clearance at 50% of design or less. The author has observed and photographed collector plates in a number of precipitators warped so badly as to be in physical contact with each other. However, collector plates in this condition have been successfully repaired as described later in this paper.

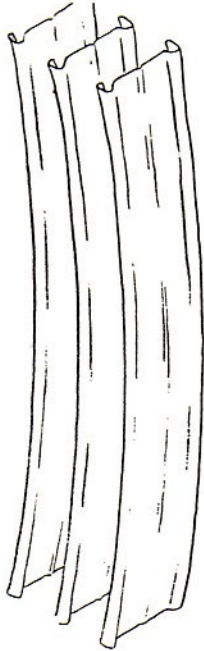
Certain collector plates tend to be more conducive to distortion than others. The trend in weighted wire ESP designs has been to smaller plate stiffener baffles. The smaller baffle provides less rigidity over the length of the plate, and less resistance to distortion. Many rigid frame designs utilize long narrow collector surfaces commonly referred to as "strip plates". These plates typically

provide an extremely small stiffener baffle integral with the plate. Thus, a plate can be made simply by passing the metal plate through a roll former. The degree of bow in the original plate depends on the accurate adjustment of the rolls. It is not unusual for large numbers of such plates to be bowed in their original condition.

FIG. 4 "STRIP PLATE" DISTORTION
